Servicing the Jaguar E-Type Series-1 Turn Signal Switch

Text and Photos by Patrick McLoad

December 2007

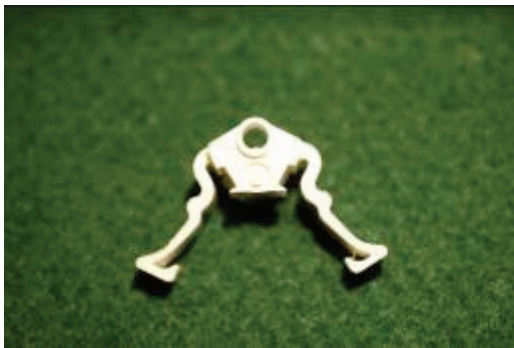
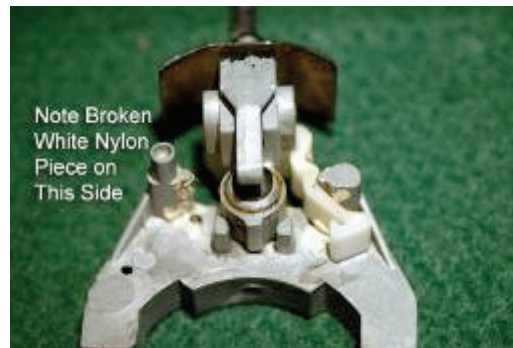
I had two annoying problems in regards to the turn indicator on my '66 OTS E-Type (1E1.445). First, the turn signal indicator lights on the instrument panel were not flashing although the exterior lights did, and, the “detent” or “action spring” device that holds the signal shaft in the upper or lower position (until after a turn is made) was broken. If you’re replacing this part, make sure you have it on hand before starting this procedure as they are somewhat hard to come by from time to time, and you may be waiting months for it to come in. (The SNG-Barratt part number is 54320721, and they call it an “action spring”.)

This ***IS*** a job that almost anyone can do with a few simple tools. New (replacement) turn-signal assemblies are available for about \$300, and for all I know, they have re-designed the turn detent mechanism to something that works better. If you need to replace the signal shaft due to peeling chrome, you might be better off to just buy a new replacement assembly. (However, a new shaft CAN be installed if you have access to a small hobby lathe...but that is outside the scope of this article). These turn-signal action springs aren't exactly cheap either...the two or three parts houses show them at \$80 each. (Do not confuse this part with the steel ring on the column whose “finger” resets the turn signal to its neutral position after a turn is made.) But if you want to stay original, then this is the way to go. I would advise you to print and read through this before removing the switch assembly from your E-Type as there are some do's and don'ts you need to know about.

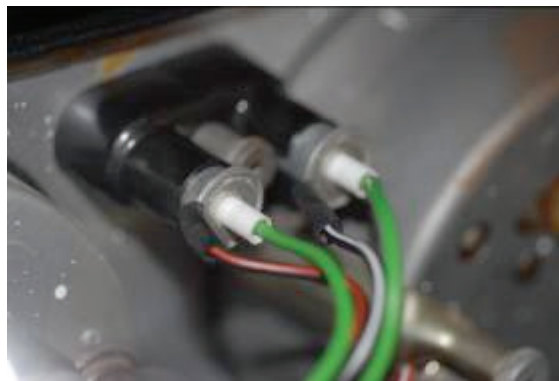
I was puzzled by why my panel indicators weren't working; running down electrical gremlins is not high on my list of favorite things to do. I knew the fuse was okay because the exterior lights blinked. I also deduced that the flasher unit was not going to be the problem because both circuits (R&L) worked fine (besides, it would have been far too easy a fix on an E-Type!!). Next to check were the bulbs themselves, but getting to them is a whole different ballgame. I removed my dash panel to expose the top part of the instrument panel. The turn indicator lamps are in two individual sockets, each of which push into a plastic piece that keeps the lights separate from one another (below).

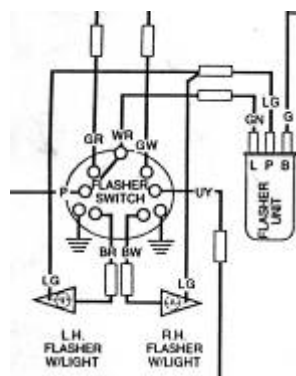
I pulled out the sockets, unscrewed the bulbs and did a bench test of both and they were good. Each light socket has its own individual ground wire. Knowing that a bad ground is usually the culprit in restored E-Types (due to painted surfaces), I ran a little alligator clip from the socket exterior to a good ground, and sure enough, the indicator lights worked. (Had this grounding test yielded nothing, then I would have to use a volt meter to check the presence of 12 VDC on the center wire.) So I had to hunt down these ground wires....they were not simply black wires that ran over to a convenient terminal on the body. They actually had a color code on them (black/red and black/white) and they ran down to the switch harness.

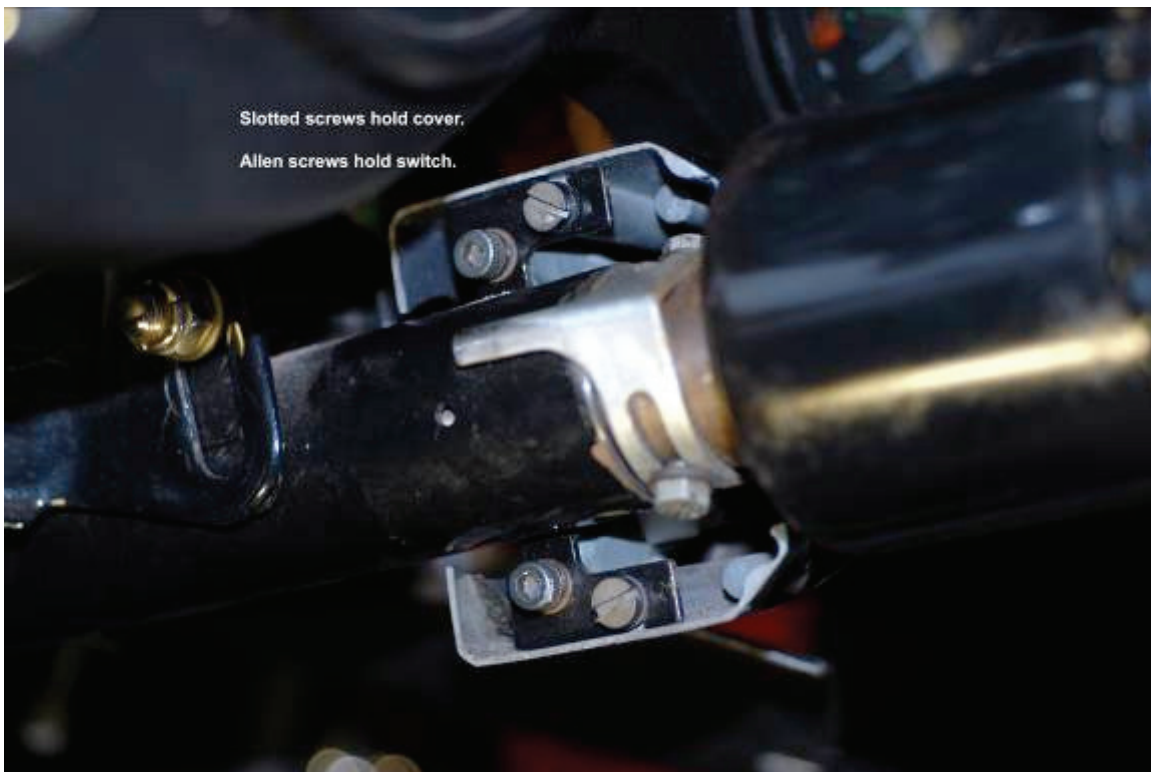
The “short” side of the cover surrounding the switch will separate easily as it is only held on by internal spring tabs (no bolts or screws). Use something wooden or plastic to begin the separation, then a screw driver to pry it off (careful of the paint!!). The internal spring tabs are holding onto the steering column itself. Now you can see two **slotted** screws that hold the other half to the column. Back these off and remove the other part of the cover. Spin the screws and split washers back onto this cover so you don’t lose them.

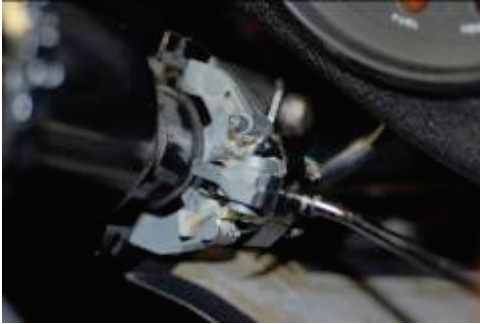
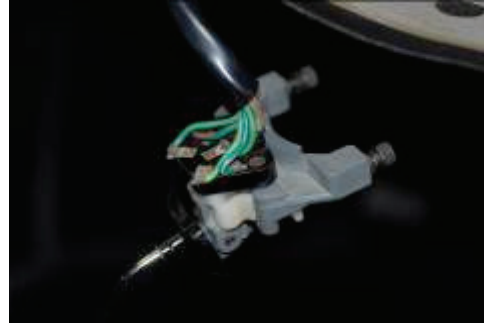
Now you will see the switch assembly which is being held to the column by two **allen-head** screws. Remove these two screws, and again, spin them back onto the aluminum casting. The switch assembly is now much easier to get to for removal from the car. Just to be on the safe side, make notes on wire color codes and to what color they mate on the main harness.

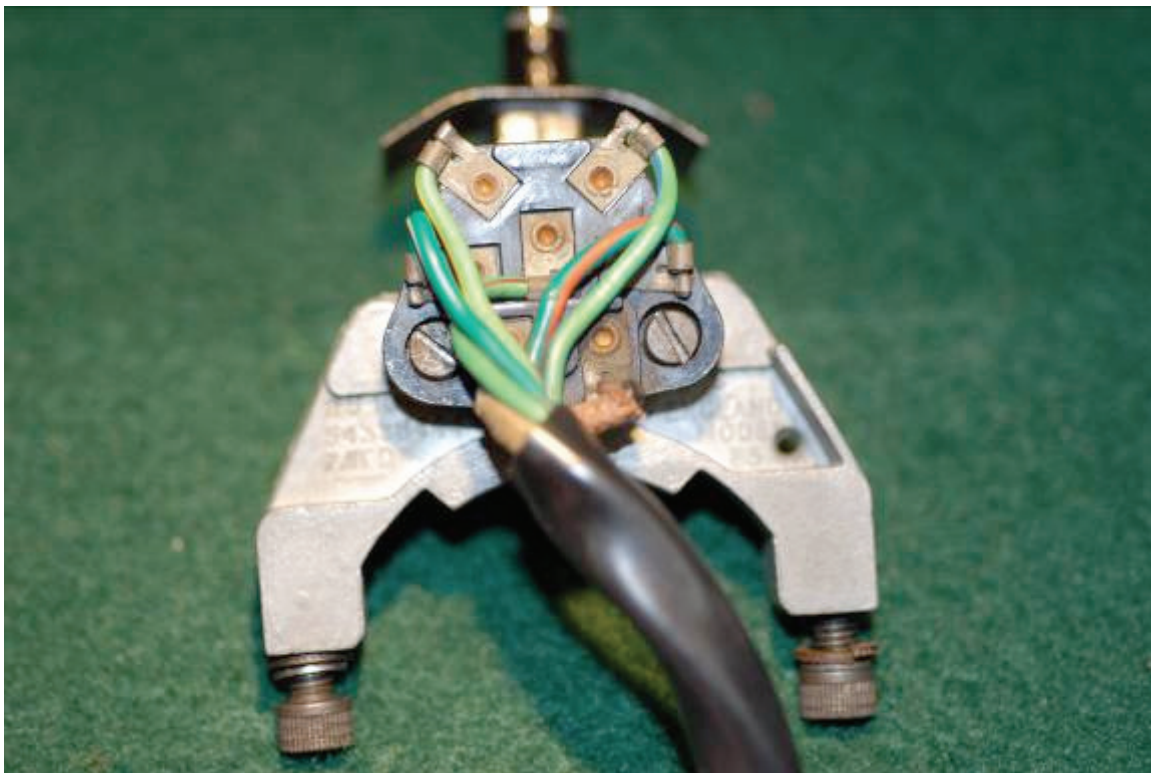
Now to the bench with the assembly. Make sure to have a large light-colored towel on the bench top to work on. This will help to catch small parts should they fall, and provides a good contrast. **Keep all other clutter away!** Grab another cup of coffee and study the switch mechanism closely. Although you can find a good assortment of springs at a hardware store, you really don't want to lose **any** of these small parts! Putting them in a small plastic bag is a good idea too.

There are two small screws that secure the contacts to the aluminum casting (above). Be advised that there are springs under this contact, so as you back off the screws, keep the contact piece firmly in place (and facing up) with your thumb and forefinger. **Important: Do not subject the two screws to the pressure of the springs as you are unscrewing them. The internal threads in the casting are quite fragile and are likely to strip. This is cast aluminum, not steel!!** Again, keep pressure on this contact plate until the two screws are backed out all the way!

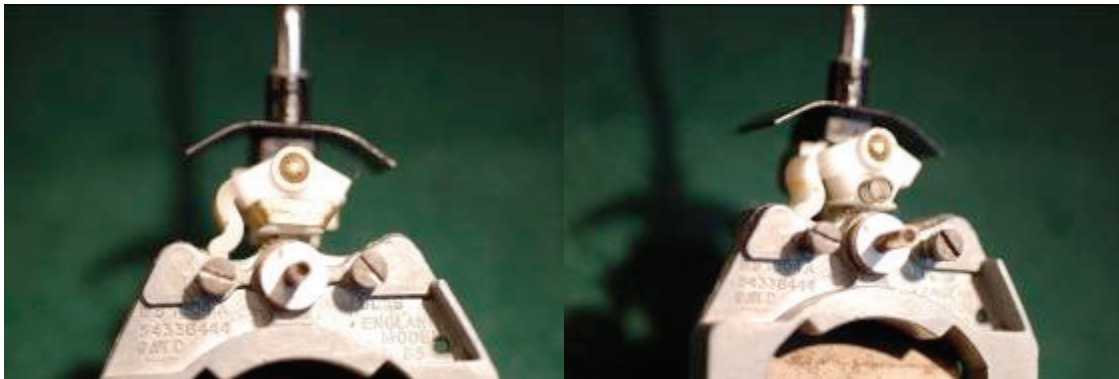
As you carefully remove the contact plate you will see a part that has two springs on both ends, and, a U-shaped contact with a spring under it. The white nylon piece is the turn detent device (action spring).

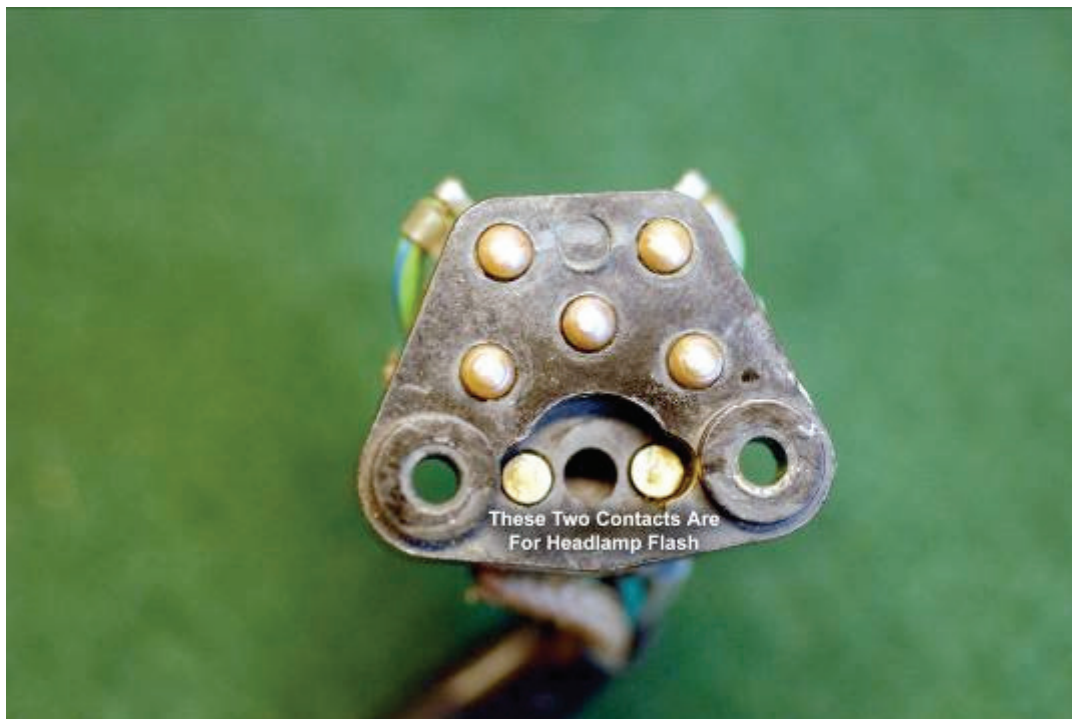
Check all of the contact buttons for pitting or corrosion (above). You can dress these contacts with 1000 grit wet and dry sandpaper or even a pencil eraser, but they should be clean and shiny. If they appear to be badly pitted or worn down, you might as well just buy a whole new switch assembly. These contacts only experience 12 volts (DC) so pitting from sparks or arcing shouldn't be an issue. However, you'll see two connections down in a hole that lead to thick wires. These are contacts for the headlights flashing feature when the turn-signal shaft is pulled inward. A single metal disc connects these two contacts which turn on the lights. Place the contact piece off to the side as well as the small springs and other parts.

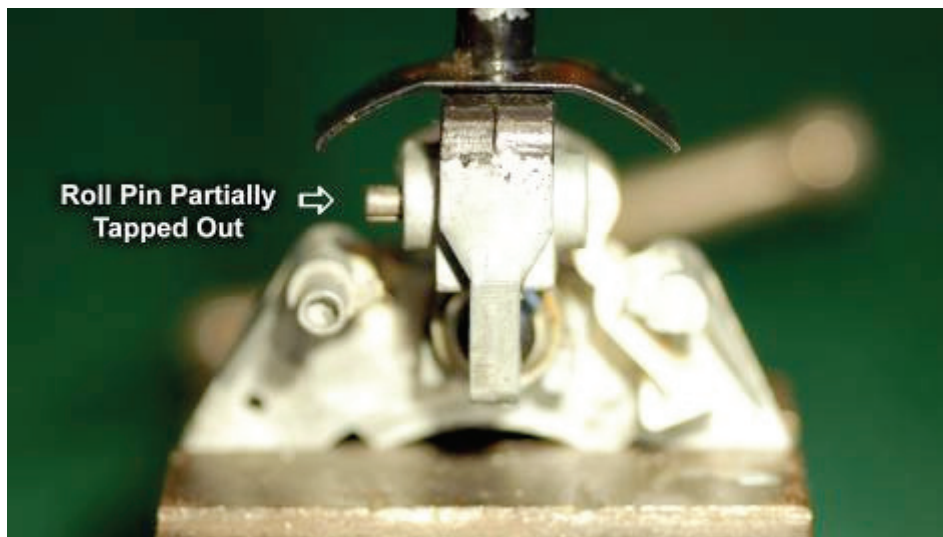
Next, remove the turn signal shaft. Carefully mount the casting in a small machine vise. Tap out the roll pin with a punch or nail set. It shouldn't be in there very tightly, so tap lightly.

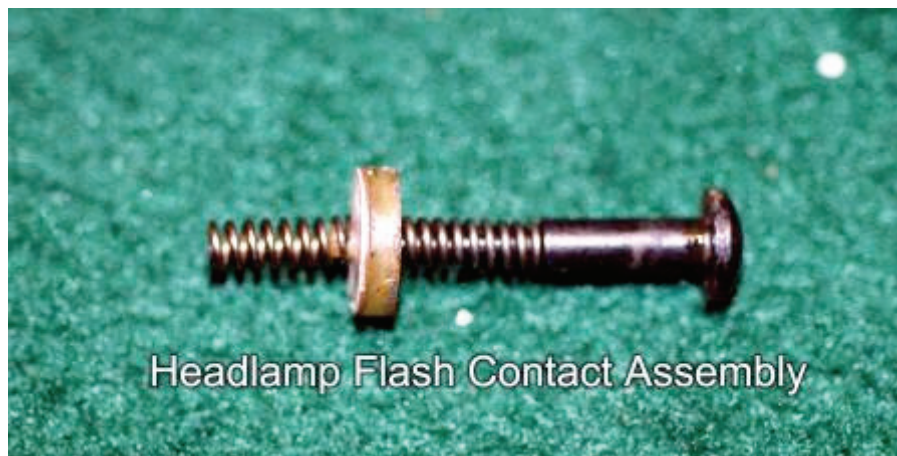
Note the black plastic pin that runs through the casting (above). This pin inserts into a spring, which is followed by a plastic disk, a metallic contact, and then another spring. Note the plastic disc has a lip on one side and is flat on the other. The metallic disc always goes on the flat part of the plastic piece. Look at both sides of the metallic disc. The back side seems to have a copper coating, while the front side (that makes contact with the two headlight leads) is brass in appearance. Clean up the brass side with 1000 grit paper or 000 steel wool. If this side is badly pitted for some reason, I suppose you can use the copper side for the contacts.

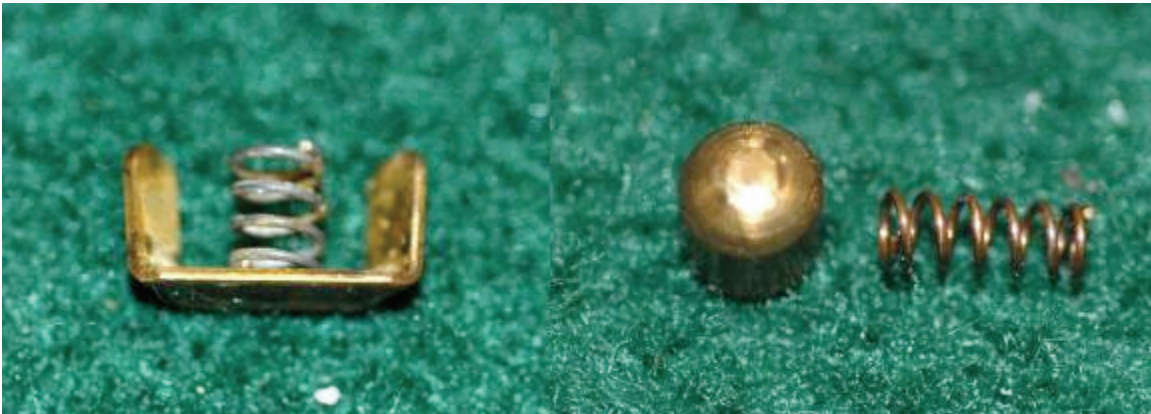
Moving on, the U-shaped contact piece (above) should be clean and free from pits as well. Just don't forget the spring that fits under it! The U-shaped contact only fits one way, so you're pretty safe in getting this right. (There is a round cut-out in the white nylon detent for this spring.) There is also a round, bullet-shaped contact with a spring behind it that will have to be removed. It is supposed to be a slide fit, so if it will come out, that's fine, otherwise you may have to wait until the detent has been removed. (More on this little contact later.)

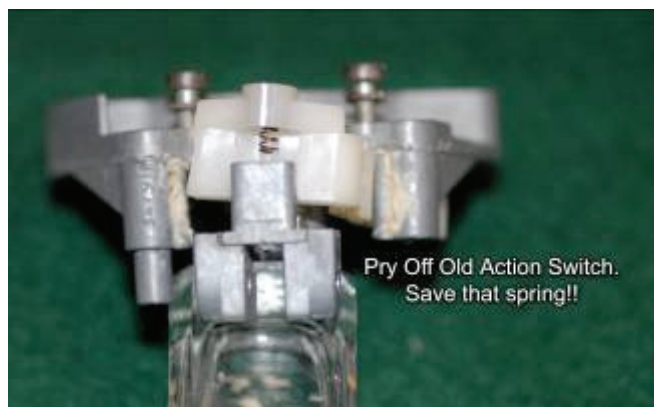
Carefully pry off the old broken action spring (above). With a Q-tip and solvent, clean off any old grease on the casting. Apply a couple of drops of clear machine oil in the moving part. We're now ready for re-assembly.

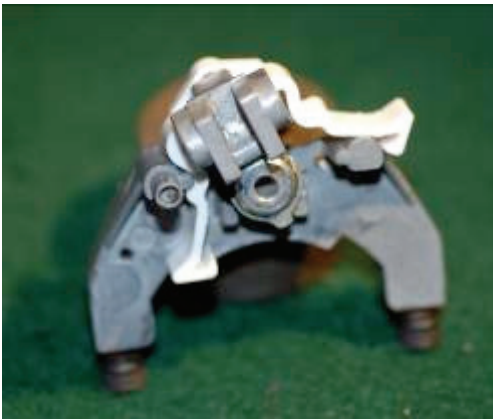
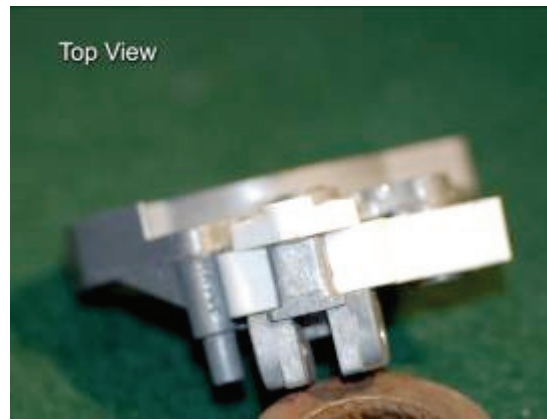
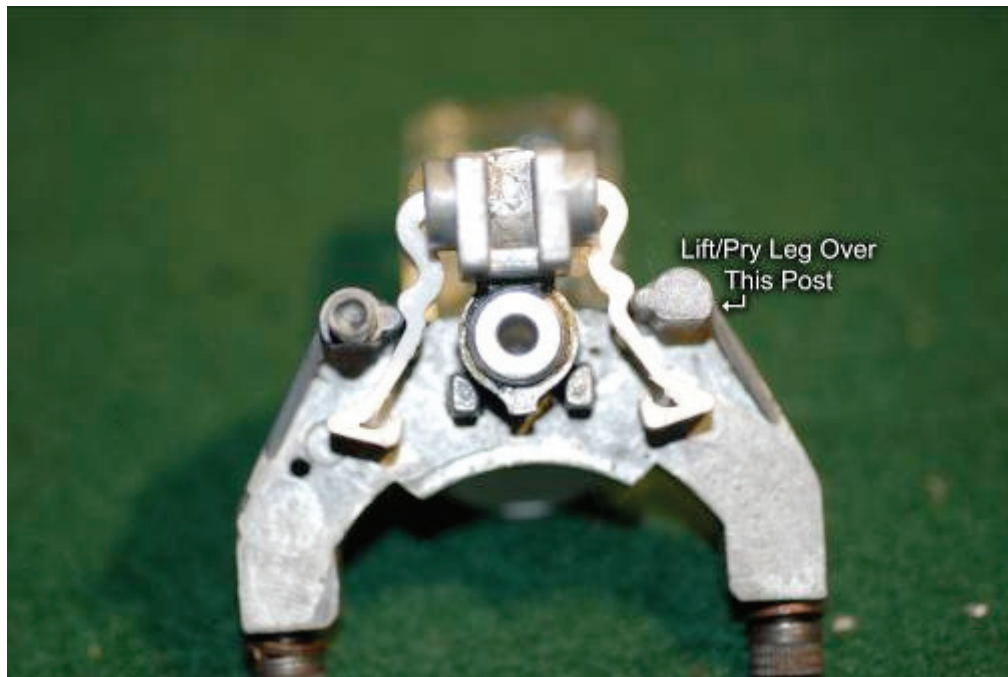
The detent piece is made of nylon and is a pretty tough customer; it can take a lot of bending without breaking. Here is a photo of how I started the insertion of the new piece. Note that on one side of the casting is a post that is longer than on the other side. Place the detent arm in that space, then work the top part into place...it will take a bit of force. The photo below shows this first step already done.

Lastly, pry the other arm up and over into position. (Now you can see why I avoided the taller post on the left!) You can try a different procedure, but this is the only one I found that works. With a small artist brush, apply white lithium grease in the areas where the detent works against the casting. Put plenty of grease in there and work the mechanism back and forth, but don't get too sloppy with the stuff.

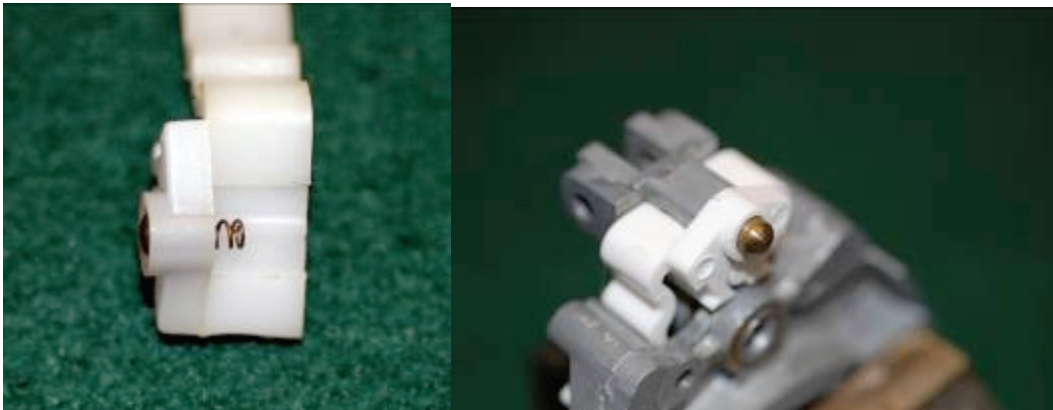
So back to my problem with the indicator lamps, where is the ground in this switch for the instrument panel indicators?? A-ha! There it is! The button contact at the top of the nylon piece has a spring that pushes against the casting body, essentially grounding this button contact. So the whole assembly is the ground...there is no ground wire. **It is important to note that this button contact, working against the small spring, MUST slide freely in the hole!** If it does not, then your detent part is defective.

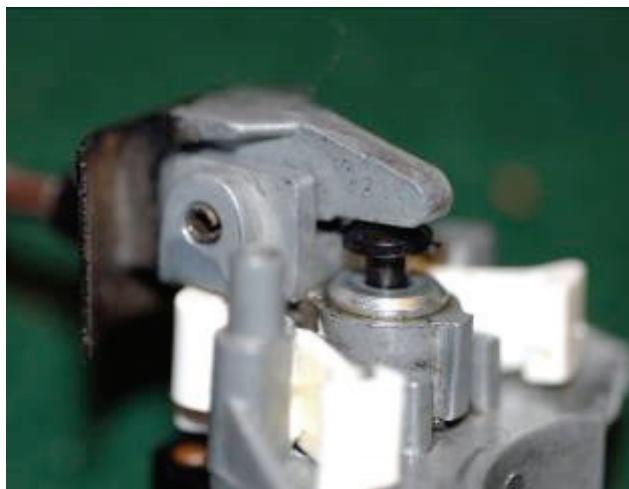
Place the black button/pin back into the hole (above) and reassemble the turn signal shaft onto the casting via the roll pin...tap lightly until flush. If your turn signal shaft needs any paint, do this painting before reassembly.

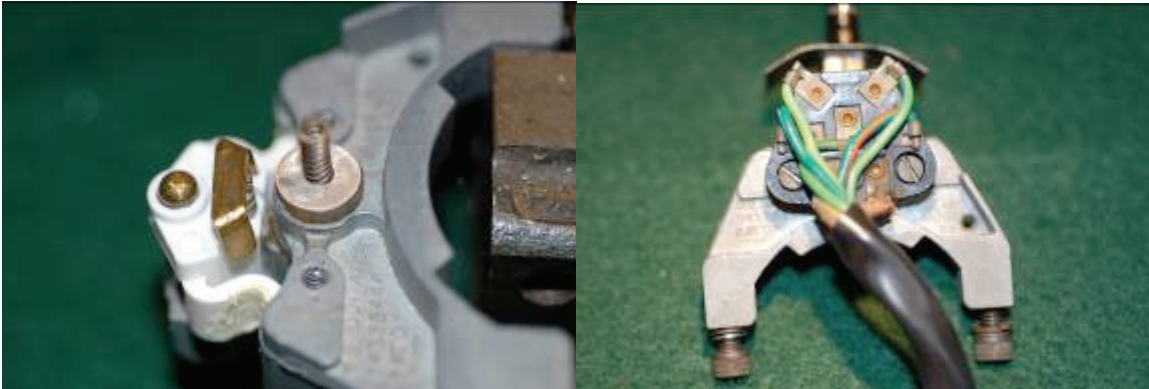
Now, with the casting facing upward (above left), insert the small spring and balance the U-shaped contact on top of the spring. Insert the 2-spring contact into the hole, remembering that the tip of the black pin inserts into the spring, and, the contact disc faces upward. Offer up the bakelight contact piece (with wires), first lining up the long spring with it's corresponding hole. Press and hold the contact piece firmly to the casting while you thread in the two small screws. **Remember, you DO NOT want the threads of these screws to do the work of pulling this piece down against the springs. If you do, you run the high risk of stripping out the threads!!** *(If this does happen, run a #8-32 tap through the hole(s); use #8-32 screws that are of the EXACT length as the originals; and round off the heads to where they fit into the screw head holes. This is easily done by putting the screws in a drill, and filing down while the screw head spins. 10-32's are too large, so if the 8-32's don't work for some reason, you're SOL and will have to buy a new assembly. [The screw threads-per-inch on the original screws is some weird metric or Whitworth size]).*

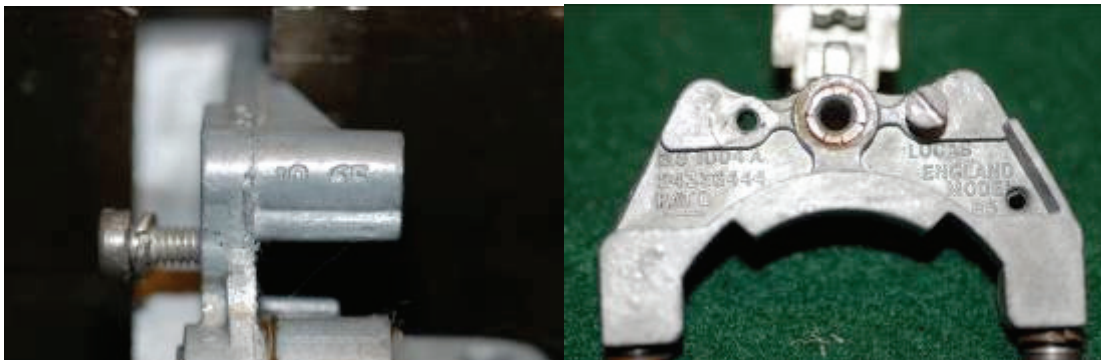
And for those who are really anal about originality, the turn signal casting DOES have a date on it. Mine shows 10/65 (Oct. '65) for my car that was made in January 1966.

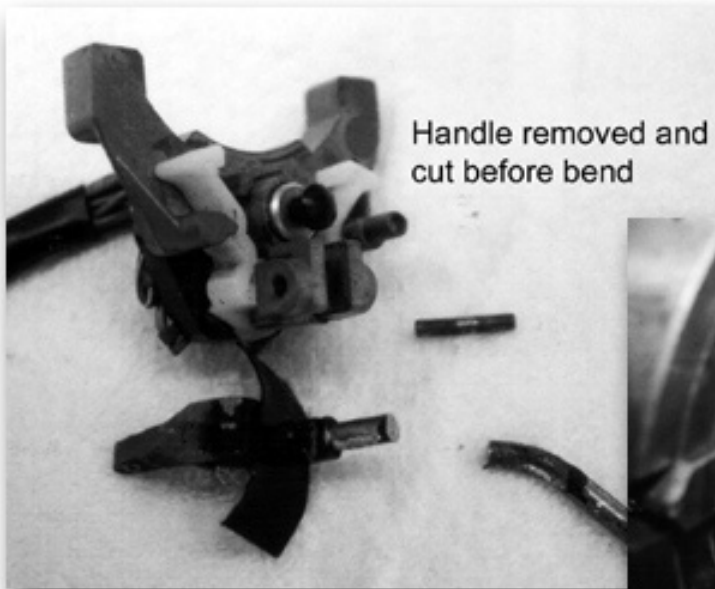
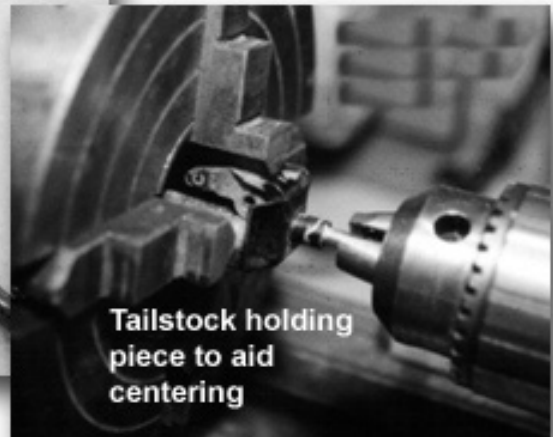
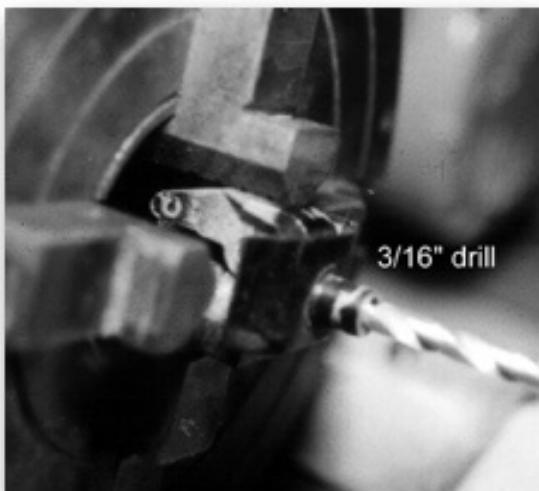
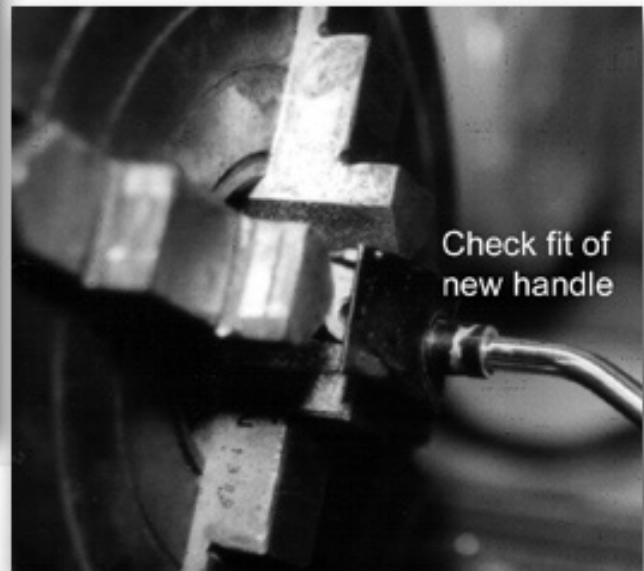
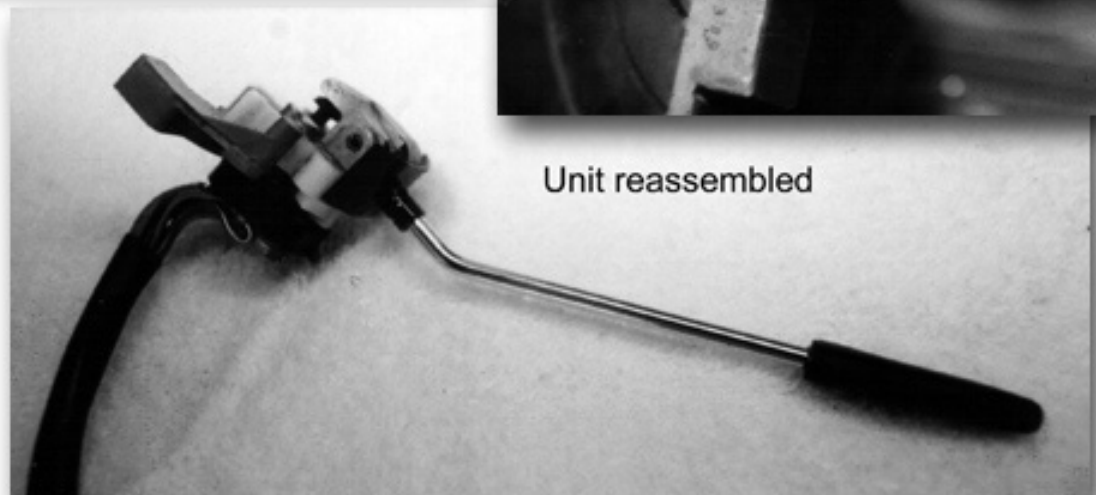
PS: I mentioned early in this article the job of replacing the turn signal shaft. As you can see in the above photos, it is firmly attached to a cast aluminum piece that I will call the "anvil". To the best of my knowledge, replacement signal shafts do not come with this part attached. So what you will have to do is cut off the old shaft and drill out the material from the anvil socket using a small hobby lathe....the chances of your doing this successfully using a drill press are remote at best due to the thin wall of the socket. The montage below will give you an idea of what is involved.
